Company Profile

About CIAP (PVT) LTD.

CIAP		ENGINEER'S SERVICE REPORT	
Serves with professionalism			
224/C, Bandaragama Road, Kesbewa, Sri Lanka +94112702889 +94719645645 Email: ciapinfo@ciap.ltd ciap.ltd@yahoo.com			
Customer: MSC SI	Address: MSC House,		
Contacted Person: Mr	Contact Number: +31 7 222 2222	Report Date: 20.03.2022	
Work Commenced Date & Time: 03.02.2022 @ 0800 HRS		Work Completed: 20.03.2022	
Vessel Name: MSC I	IMO No / Call sign	GT: 13764	
Work Order Number: WO22/02/00001	Your Ref:		
Work Scope: Main Engine Exhaust valve to overhaul Main engine Fuel Pump Overhauling FO roller guides to overhaul Exhaust valve Lo actuators to overhaul Unit overhauling Boiler burner overhauling, ringline overhauling and automation trouble shooting. Maneuvering system trouble shooting GE alternator servicing			
Defects Noticed: Jobs to be attended as above			
Work Done and Defects rectification.			
Main engine Exhaust valves (7 Units) All seven exhaust valves were taken out along with the manifold distance piece and following work carried out. When taking out exhaust valves same tested prior overhauling found all exhaust valves are dropping within 3-5 min time. <ol style="list-styl

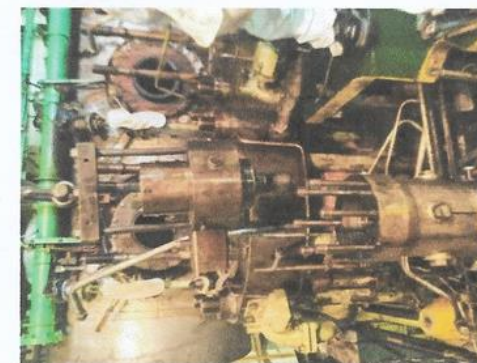
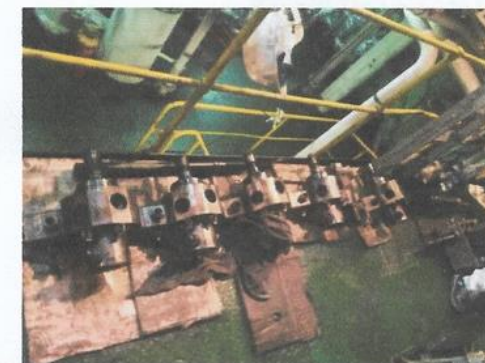
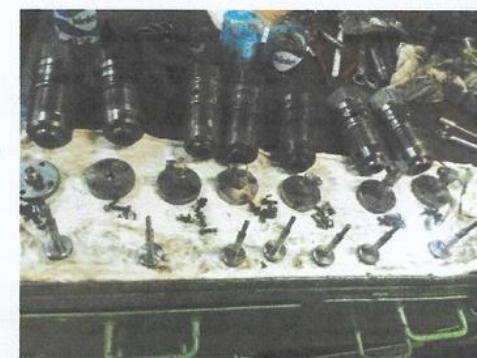
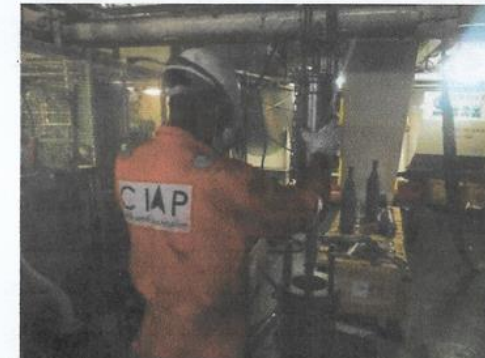
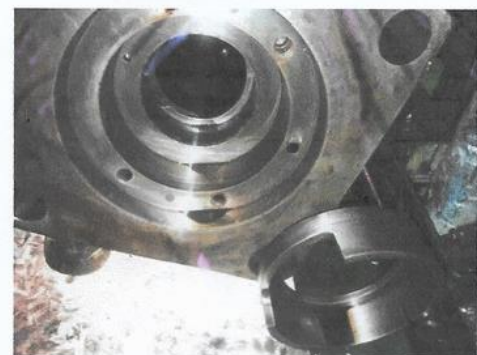
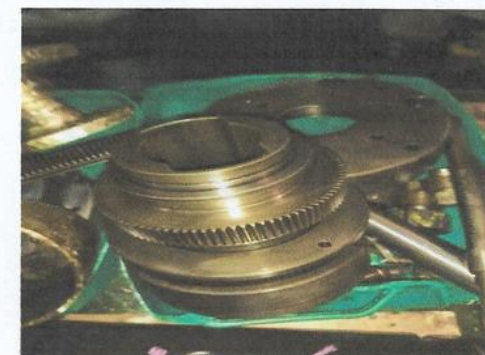
Engine Fuel Pumps (7 units)

Fuel pumps taken out from engine. And following work has been carried out in Main engine fuel pumps.

1. All fuel pumps overhauled
2. Top cover, Pump housing, rack, VIT, Drive gears are taken out and cleaned.
3. New plunger barrels used for six units with new seal rings.
4. One Old plunger barrel used for remaining unit after inspecting the internal condition and the tightness of the same.
5. All boxed back with new seal rings.
6. All puncture valves opened up, cleaned and boxed back with new seal rings.
7. All suction valves boxed backed with new seal rings.
8. All fuel pumps boxed back as per maker's instruction and check the free moment of the plunger and found all ok.
9. All fuel pumps mounted on base and all found in order
10. New seals were not available for umbrella seal. Same informed to ship staff and to be renewed the same at the earliest

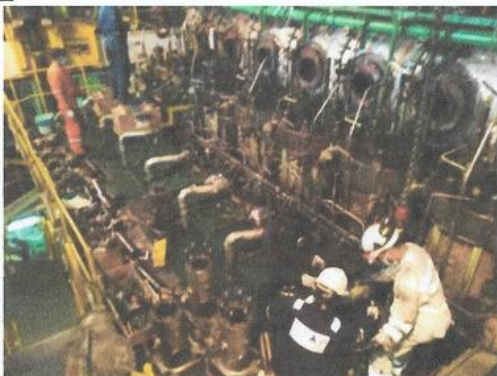
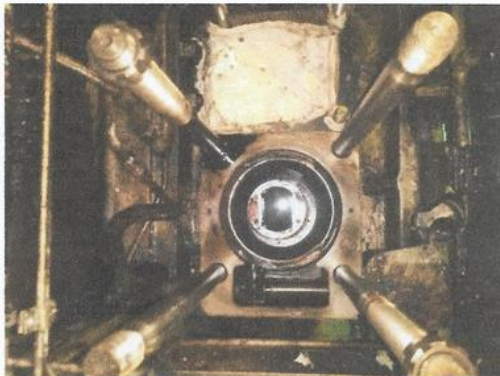
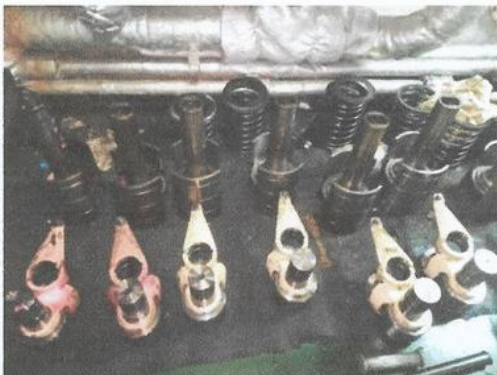
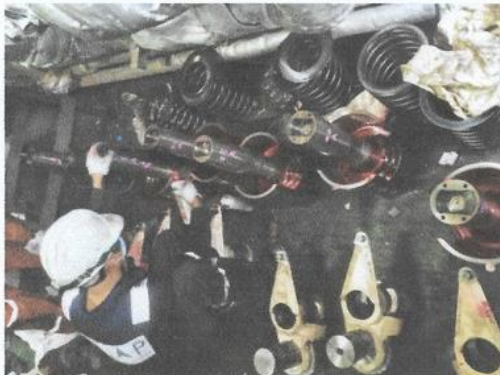
FO roller guides (7 Units)

All roller guides taken out and following work carried out.

1. All roller guides taken out.
2. All overhauled and crack test carried out, no cracks found and all in order.
3. Bush clearance checked and all found in order.
4. One drive pin roller coming out due to collar damage. Same showed to ship staff and made sure its secured.
5. All rollers boxed back after makers Instruction and roller actuator drive arm clearance adjusted for smooth operation. All checked for proper operation and found satisfactory.

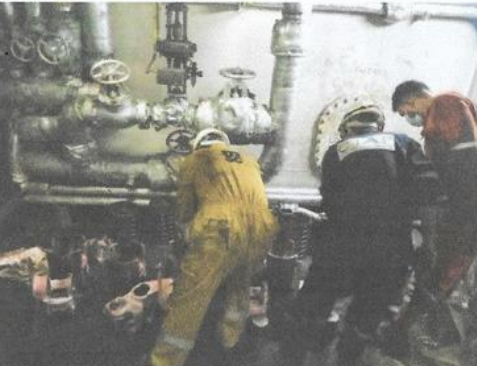
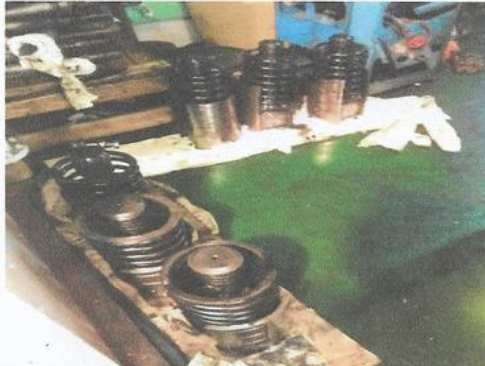
Exhaust valve actuator (7 Units)

All exhaust valve actuators taken out from engine and following work has been carried out.

1. All actuators taken out and overhauled.
2. All parts cleaned
3. Crack test carried out on the same and found no Cracks and all found in order.
4. Same boxed back on engine as per maker's instruction and all found in order.

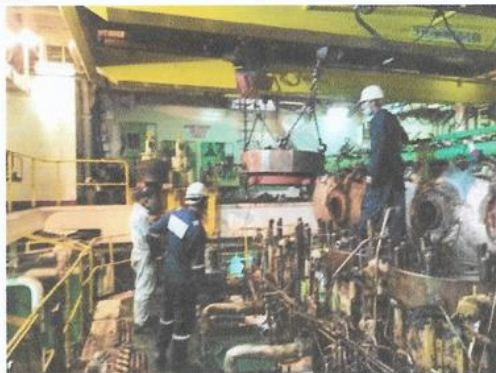
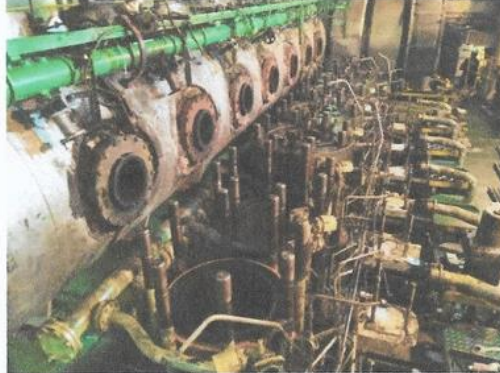
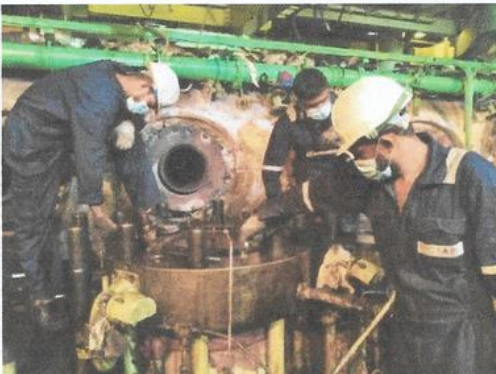
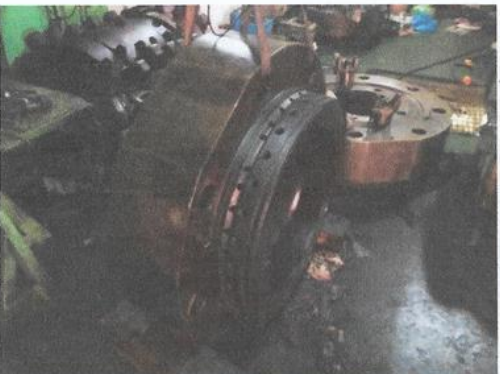
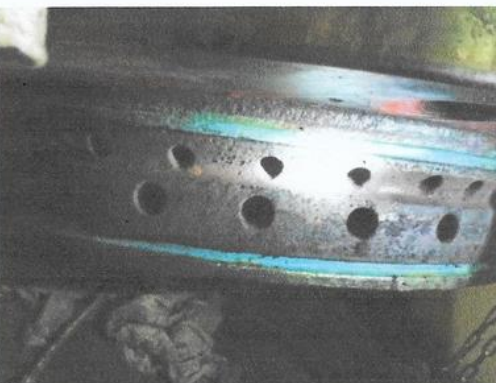
Unit Overhauling

All seven Cylinder heads taken out and following work carried out on the same.

1. All jackets removed. Found two jackets are heavily corroded due to poor cooling water condition.
2. Some of the cylinder heads cooling bores also heavily corroded and recommend reconditioning the same.
3. Starting air valves removed and overhauled done by ship personal.
4. All Fuel injectors removed and pressure testing carried out by ship staff.
5. All cylinder heads cleaned, bores cleaned.
6. 5 jackets mounted on cylinder heads with new O rings.
7. 2 new jackets mounted on cylinder heads with new O rings. Same mounted n 4 and 5 units.
8. All cylinder heads mounted on engine as per maker's instruction.
9. All cooling water connections given, water filled and found no leak in the system. All found in order.

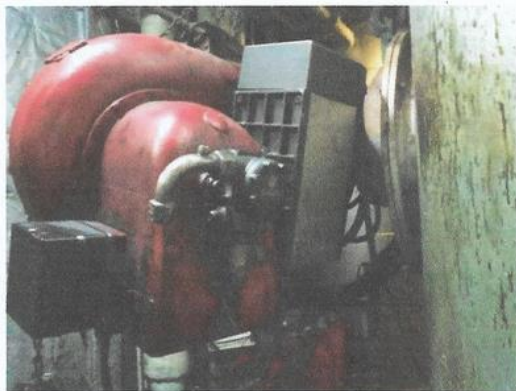
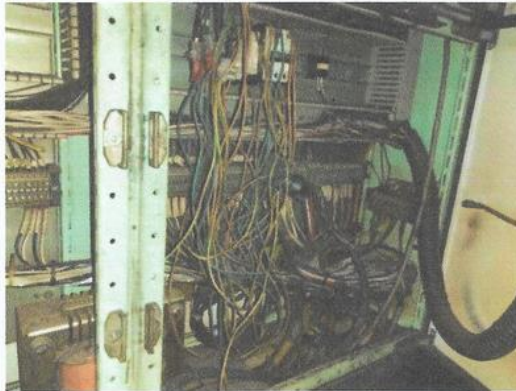
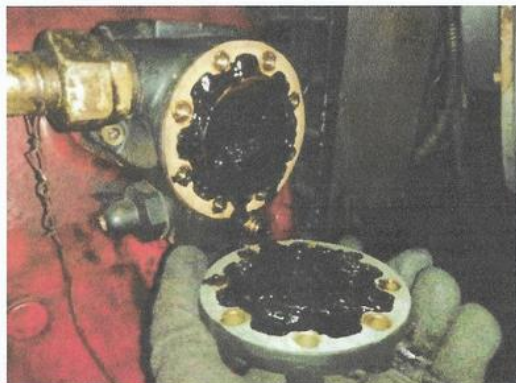
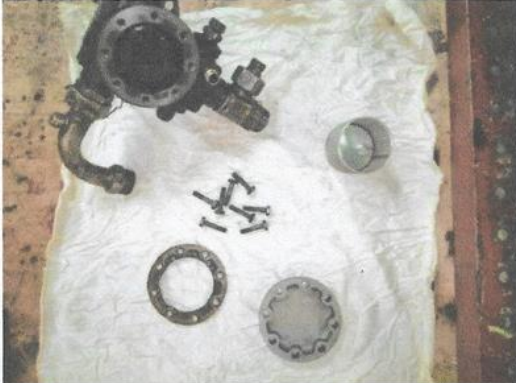
oiler

1. Boiler was not operational
2. Noticed that lines are choked with fuel oil.
3. Complete ring line taken out and flushed the system.
4. Fuel oil pump opened up and all internal parts cleaned after removing
5. Complete burner Overhauled and compete ring line flushed.
6. Compete automation system checked and notice heavy modification and system by pass in the control panel.
7. Identified necessary spares for complete rectification and same handed over to ship staff to order.
8. Control panned put back to original wiring and started in emergency mode found all in order.
9. Boiler started and in operational All found in order. Steam Build up and all in order.

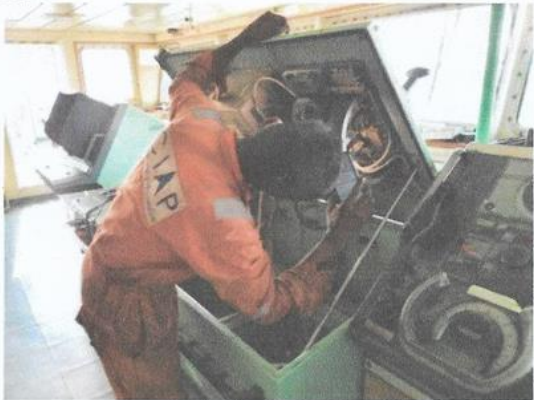
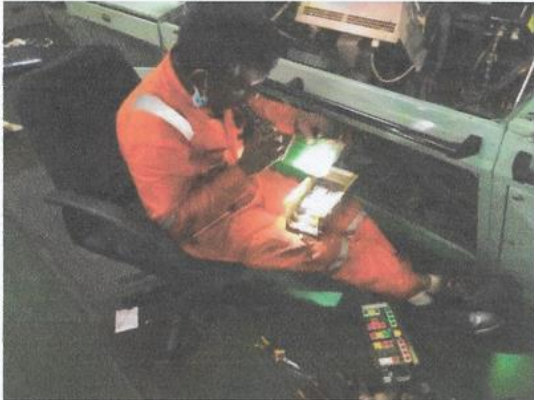
hips Maneuvering system

system inspected. Noticed "internal failure" alarm in the system.

1. Bridge consol checked and noticed that consol is not communicating with the telegraph
2. ECR consol checked found in satisfactory condition.
3. Local control consol checked and noticed that the consol is not responding at all and no Power to the consol.
4. ECR consol removed and mount to the Local consol and noticed its working in good order.
5. ECR consol shift with bridge consol and noticed properly synchronizing with telegraph and working in good order.
6. Individually checked the Bridge and local control consoles and found both some of the PCBs are not working.
7. Highly recommending to replace all three control consoles with makers spares.

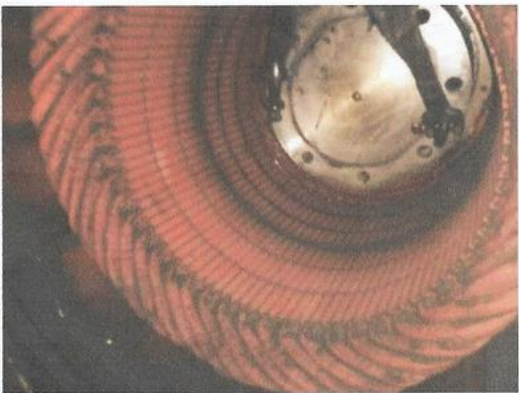
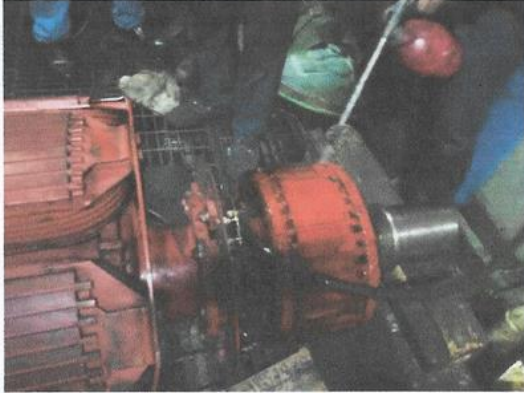
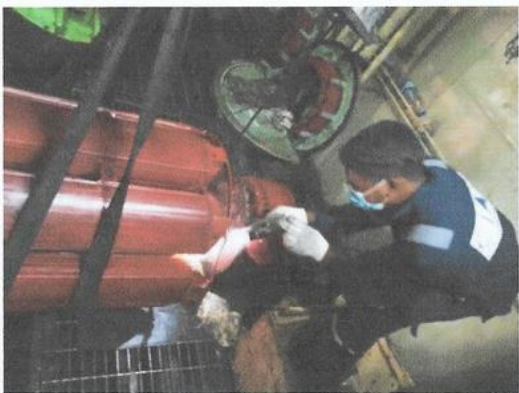
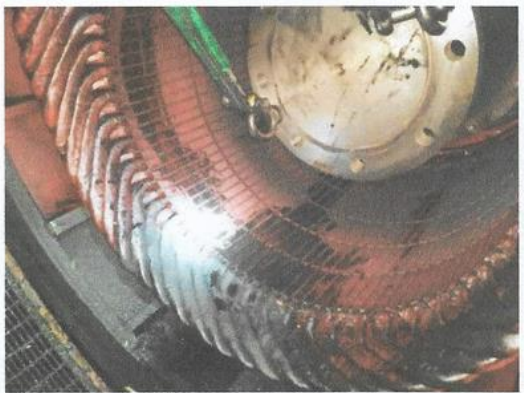
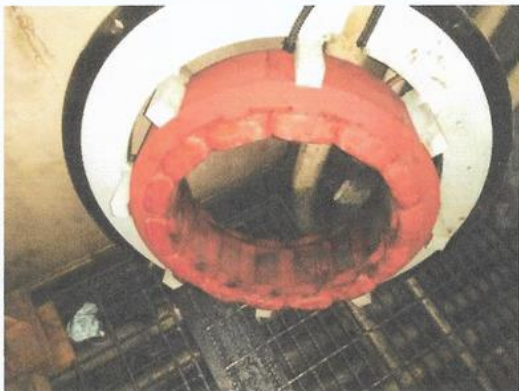
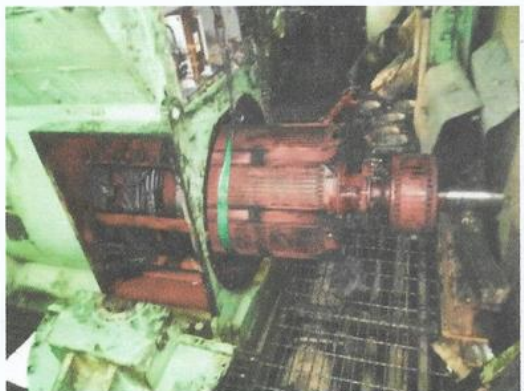
GE Alternator servicing

No 4, 3, 2, alternators opened up and servicing carried out. Following are the work carried out in alternators.

Meter Point	Before servicing (M Ohm)	After Servicing (M Ohm)
Stator	> 150	> 200
Phase to phase	> 200	> 300
Rotor	> 12	> 15
Exciter Winding	> 80	> 150

Meter Point	Before servicing (M Ohm)	After Servicing (M Ohm)
Stator	> 250	> 300
Phase to phase	> 300	> 400
Rotor	> 09	> 15
Exciter Winding	> 100	> 150

Meter Point	Before servicing (M Ohm)	After Servicing (M Ohm)
Stator	> 250	> 330
Phase to phase	> 300	> 450
Rotor	> 05	> 15
Exciter Winding	> 80	> 150

Alternator Opened up Rotor Pulled out safely after disconnecting from the supply and associated components, Properly secured, chemical washing carried out, of the rotor stator, and exciter windings and properly dried.
All baked using flood lights till it properly dried.
Same boxed back test run done, and found all in order.

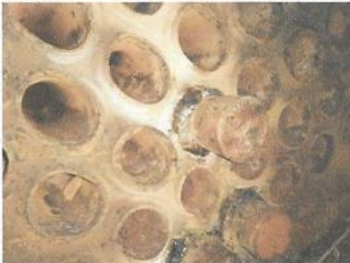
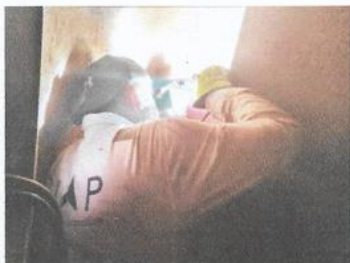
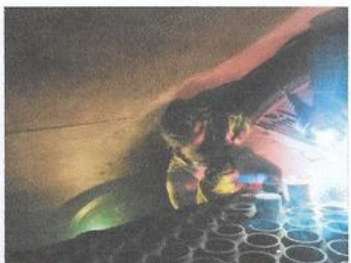
Boiler Tube Plugging

Boiler Found Leaking from auxiliary boiler water tubes. Same plugged with fabricated plugs and 6 tubes welded by clas certified welder.

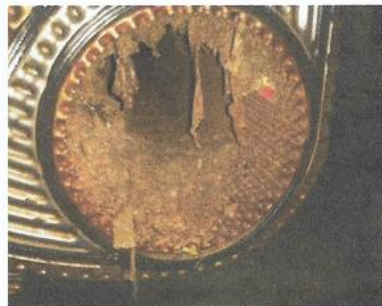
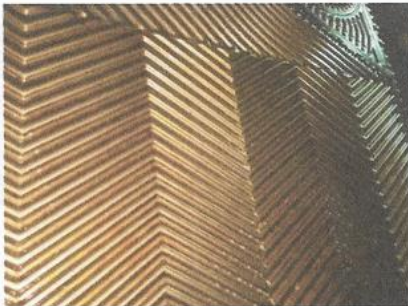
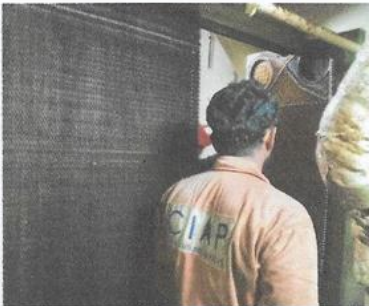
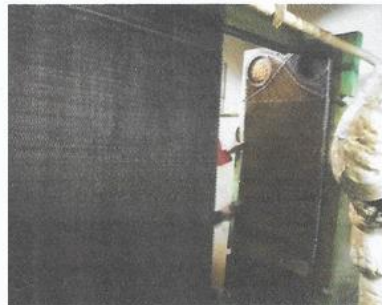
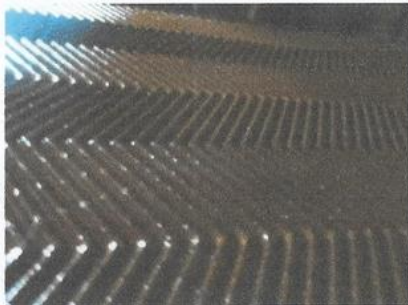
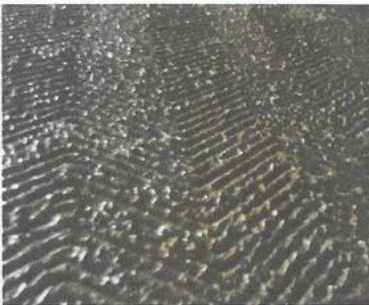
Cooler Cleaning

th LT cooler cleaning carried out
th are isolated and after making sure its holding and after taking proper dimation and length cooler opened up and both
tes are cleaned.
ticed that LT plates are with Oil staines same cleaned with DO and folowed by detergent alkaline cleaning mediam and as
sh ussed soap water tro make sure no DO stains or Oil stained on the plate.
th coolers are boxed back to the initial dimentriones and found no leak on the cooler.
ne offered to ship staff and found all in order.

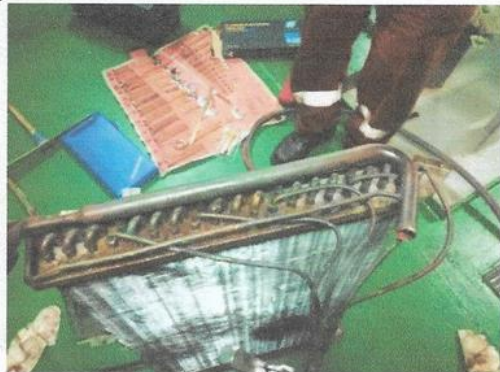
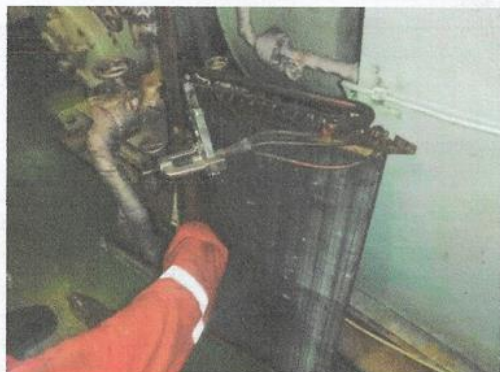
Galley Package AC

Checked the plant and less gas in the system. Same stopped and pressure tested with Nitrogen gas and noticed several leak points. Repairable leaking points were rectified. Noticed that very poor condition of the evaporator. Same showed to ship staff. On their Guidance found another used evaporator on board the vessel and It is much better condition than the existing one.

Same pressure tested and found all in order. Same fixed to the package AC and complete system pressure tested. Pressure was holding at 20 Bar for 12 hours and after same confirming by ship staff system vacuumed and gas charged.

Unit started, test run done and found all in order. Same offered to ship staff.

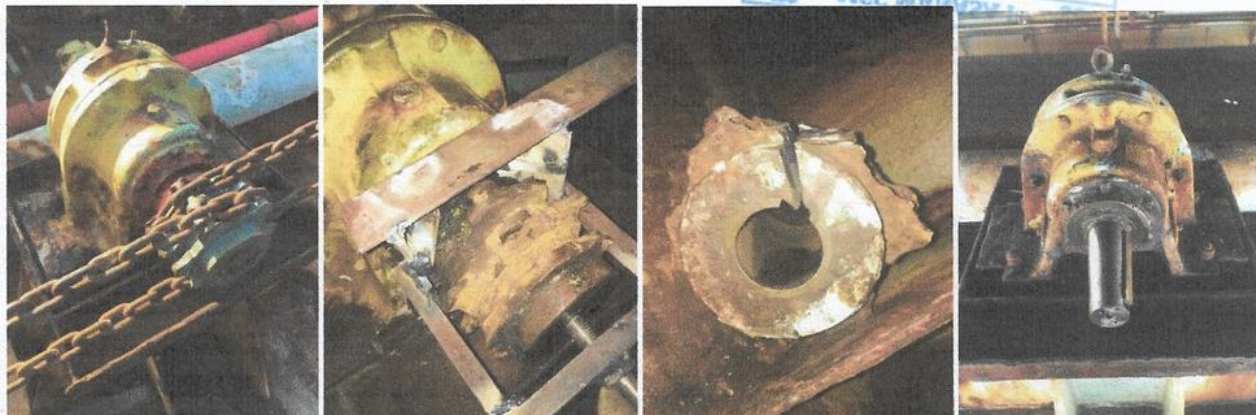
Sprocket wheels

Same was seized and tried to remove it by pulling. Was not successful.

Same cut by using cutting wheel after taking precaution not to transfer heat to e Hydraulic motor. Same Cut, removed, Shaft polished and mounted new Sprockets supplied by vessel.

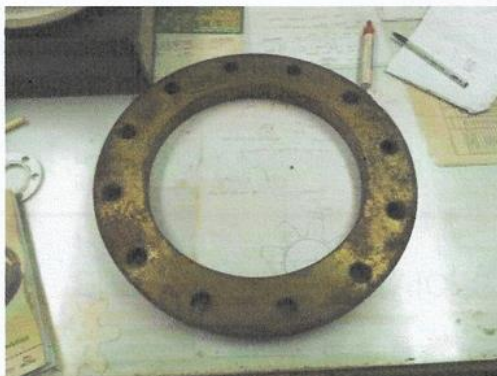
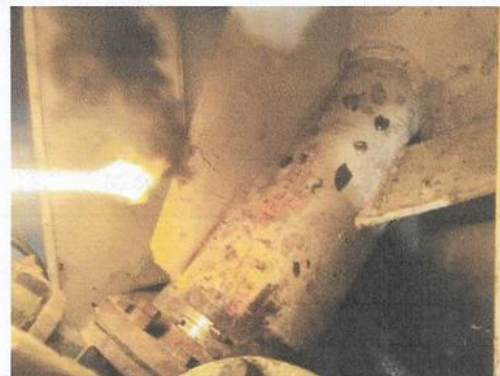
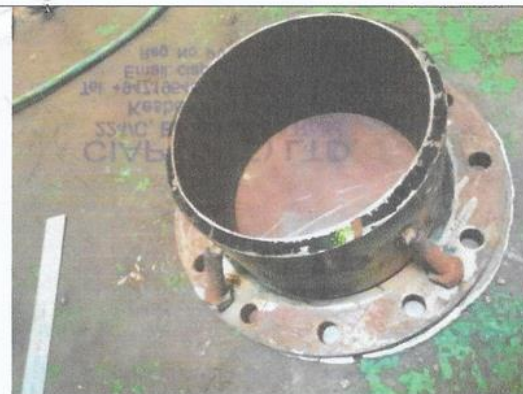
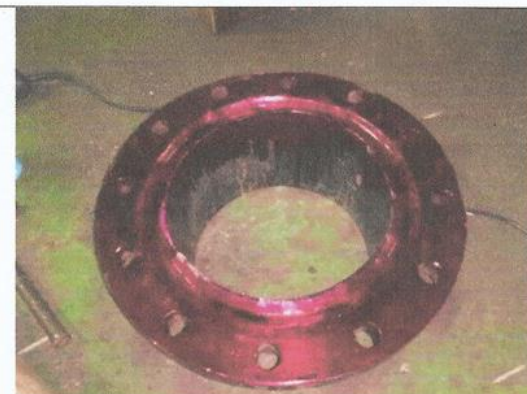
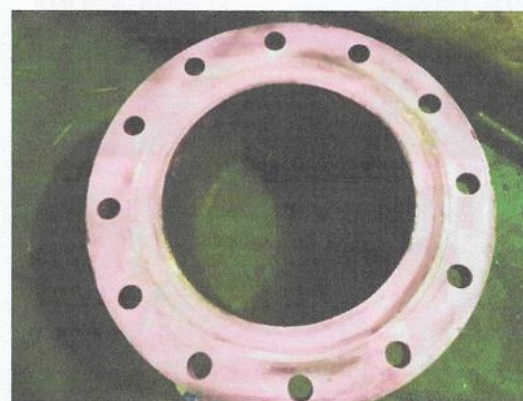
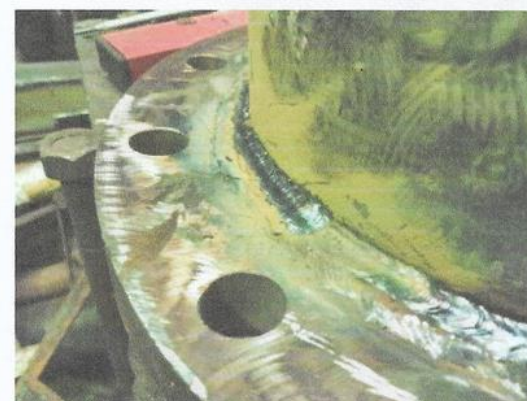
Fire and GS pump Stub piece renewal.

Heavy leaks in the evaporator
Sprocket wheels are seized in the shaft
Stub piece is leaking

- After confirming proper negative trim and plugging of overboard section, overboard valve removed, corroded overboard pipe section cropped after proper marking, alignment done after preparing existing pipe section.
- 833 insert prepared for on board to compensate increased butt clearance due to misalignment. Same insert valve and prepared pipe section mounted and welded as per class guidance and satisfaction.

After Final welding DP test carried out, ship staff applied steel putty on inner piping and completed pipe section assembled and stiffeners welded.

Final inspection done by class and work successfully completed. Pipe Mounted Without insert.
