Company Profile

About CIAP (PVT) LTD.

CIAP		ENGINEER'S SERVICE REPORT	
Serves with professionalism			
224/C, Bandaragama Road, Kesbewa, Sri Lanka +94112702889 +94719645645 Email: ciapinfo@ciap.ltd ciap.ltd@yahoo.com			
Customer: MSC SI	Address: MSC House,		
Contacted Person: Mr	Contact Number: +31 7 222 2222	Report Date: 20.03.2022	
Work Commenced Date & Time: 03.02.2022 @ 0800 HRS		Work Completed: 20.03.2022	
Vessel Name: MSC I	IMO No / Call sign	GT: 13764	
Work Order Number: WO22/02/00001	Your Ref:		
Work Scope: Main Engine Exhaust valve to overhaul Main engine Fuel Pump Overhauling FO roller guides to overhaul Exhaust valve Lo actuators to overhaul Unit overhauling Boiler burner overhauling, ringline overhauling and automation trouble shooting. Maneuvering system trouble shooting GE alternator servicing			
Defects Noticed: Jobs to be attended as above			
Work Done and Defects rectification.			
Main engine Exhaust valves (7 Units) All seven exhaust valves were taken out along with the manifold distance piece and following work carried out. When taking out exhaust valves same tested prior overhauling found all exhaust valves are dropping within 3-5 min time. <ol style="list-styl

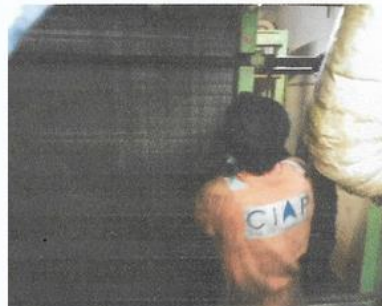
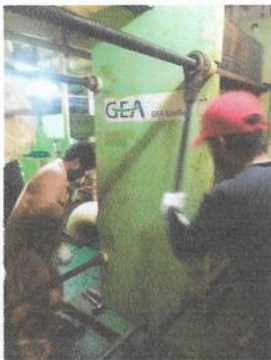
Cooler Cleaning

th LT cooler cleaning carried out
th are isolated and after making sure its holding and after taking proper dimation and length cooler opened up and both
tes are cleaned.
ticed that LT plates are with Oil staines same cleaned with DO and folowed by detergent alkaline cleaning mediam and as
sh ussed soap water tro make sure no DO stains or Oil stained on the plate.
th coolers are boxed back to the initial dimentriones and found no leak on the cooler.
ne offered to ship staff and found all in order.
